<b>Service Bulletin</b>	
	<b>Flight Design GmbH</b> Zum Tower 4 01917 Kamenz Germany Tel.: +49 (0)3578 37335 0 Fax: +49 (0)3578 37335 69 E-Mail: <a href="mailto:airworthiness@flightdesign.com">airworthiness@flightdesign.com</a>	<b>SB-ASTM-CTLS -08</b> <b>Revision 00</b>

## Replacement of Regulator A and Regulator B for ROTAX Engine Type 912iS SB-ASTM-CTLS -08

In rare cases a malfunction of the rectifier regulator with subsequent failure can occur. Only certain regulators with a manufacturing date code prior to 'week 29 of 2013' are affected.

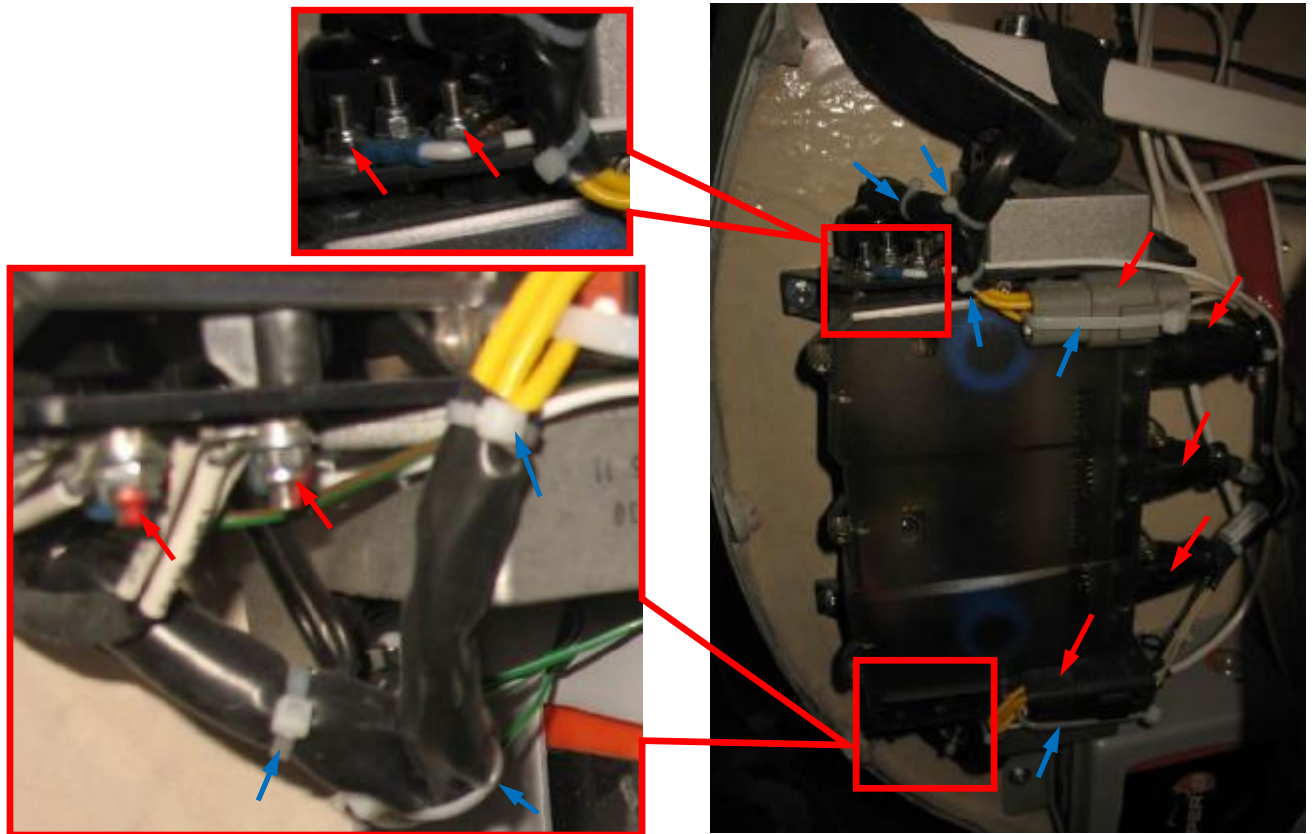
1. Make sure that negative terminal of aircraft battery is disconnected.
2. Cut securing TY-wraps marked by blue arrows, see Fig. 1. Then unplug the engine wiring harness and screw-out grounding connectors from the fuse box shown on Fig. 1 by red arrows.

2. Connect the engine wiring harness and grounding connectors to the fuse box in reverse order of 3.3.1 item 2 in according with marking. After that secure connectors and wirings with TY-wraps.

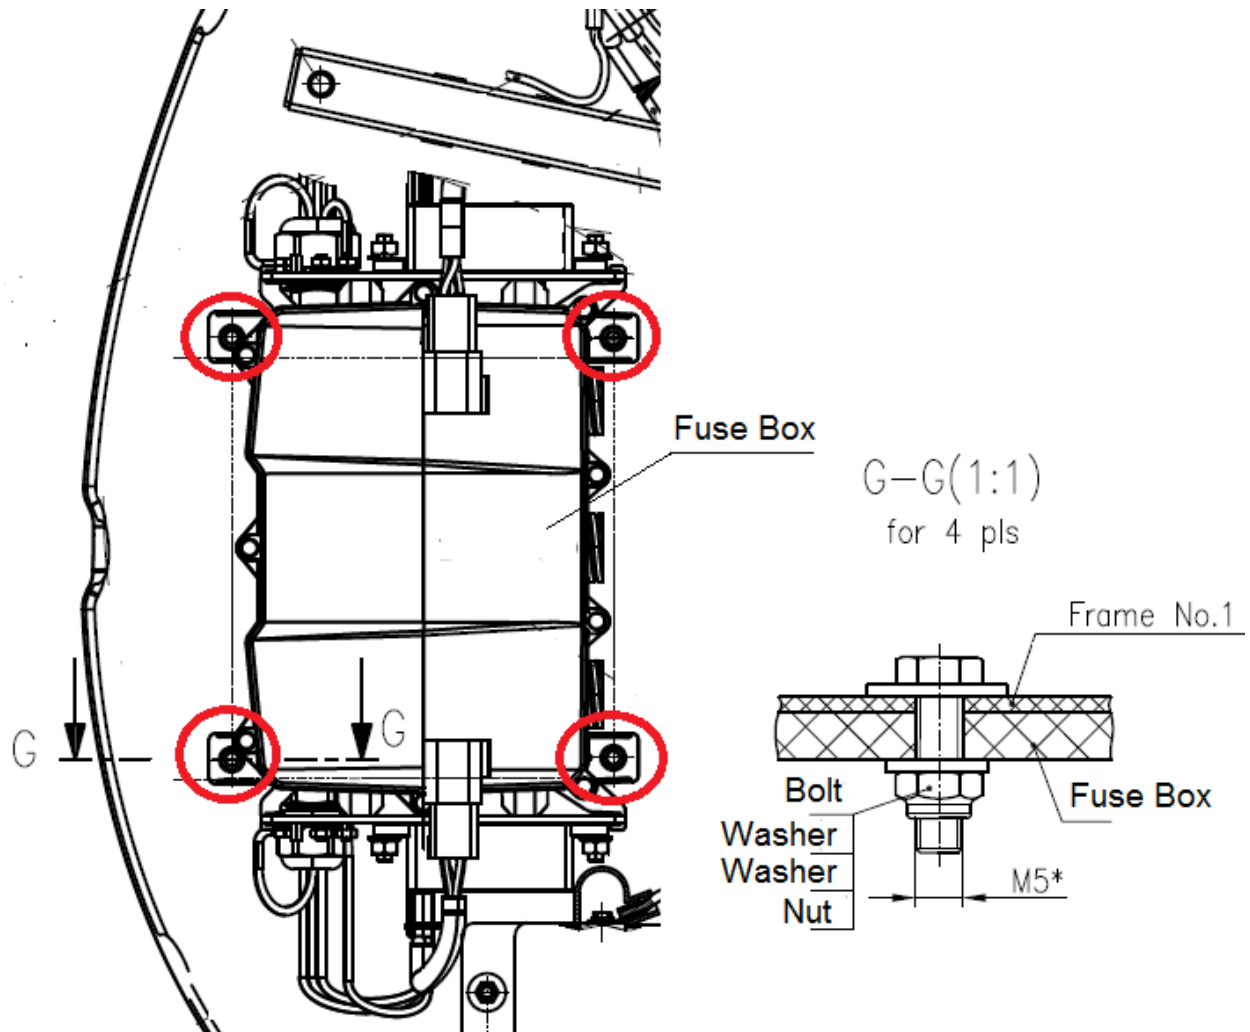
3. Remove the attachment screws of the fuse box as marked on Fig. 2 and remove fuse box from aircraft.

1. Install the fuse box in reverse order of 3.3.1 item 3.

- **Note:** For attachment of fuse box to airframe use kept bolts and washers at detaching and new self-locking nut M5, see 2.3 item 1.

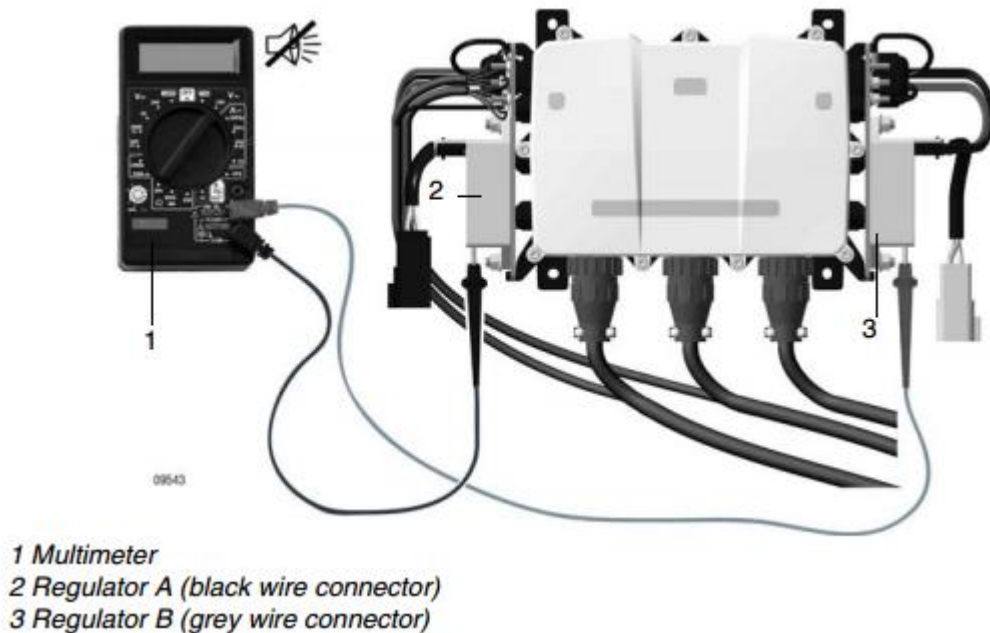
Fig. 3

After the installation of the fuse box, use a multimeter to carry out a continuity test between regulator A and regulator B in the static condition, see Fig. 3. A continuity must not be present.

- **Note:** If a conductive connection (continuity) is present, check the wiring connections in accordance with the requirements of the Installation Manual [3] and wiring diagram [KF 2400 0070\_00]. Until the error is not fixed, the engine must only be operated on the ground.
- **Note:** EMS ground may only be mounted to the regulator plate A (cooling plate of the fuse box) only. Aircraft ground may only be mounted on the regulator plate B (cooling plate of the fuse box) only.
