SERVICE BULLETIN

BRS Recovery System Handle Inspection

SB-LTUL-CTSW-04

Technical Advice No.14

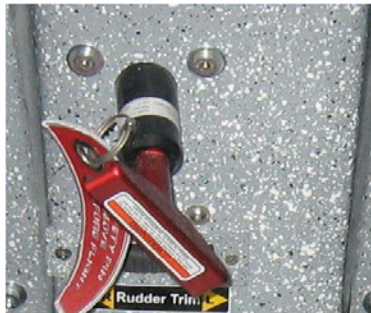
- BRS parachute system
- Parachute system activation handle mounted to the cabin bulkhead as shown below, above the rudder trim wheel.
- Parachute system handle installations of fixed, non pivot-type (shown below in Fig. 1) and mounted with a metal bracket attached from behind the cabin bulkhead

Fig. 1: BRS parachute system handle installation which is affected by this TA

Preceding this TA there was an incident where the pilot was not able to actuate his BRS parachute system and subsequently performed an emergency landing in the field. Investigation by BRS showed an incorrectly assembled activation handle which made the rocket difficult to ignite.

BRS and Flight Design are mandating an immediate inspection of the handle according to the BRS Service Bulletin SB 07-05 issued 8-24-07.

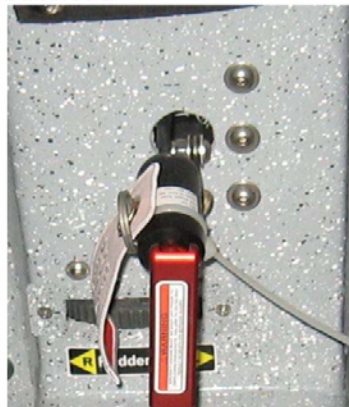
- with different parachute systems than BRS
- with BRS rescue systems that do have the new installation (planes from 07-03-07 onwards have a fixation of the handle with a "hinge" in the installation.)
- earlier BRS installations, where the handle is attached with a metal lug to the tunnel upper side or the cabin bulkhead

Fig. 2: New BRS rescue system handle installation which is not affected by this TA
