SERVICE BULLETIN	
	Flight Design GmbH Sielminger Str. 51 D-70771 L.-Echterdingen Tel +49 (0)711 90287-0 Fax +49 (0)711 90287-99 E-Mail: airworthiness@flightdesign.com	SB-LTUL-CTSW-07 Revision 00
		Date of Initial Publication: 30-Nov-2009 Publication Date of this Revision: 30-Nov-2009

Stabilizer Rear Wall Stiffening SB-LTUL-CTSW-07

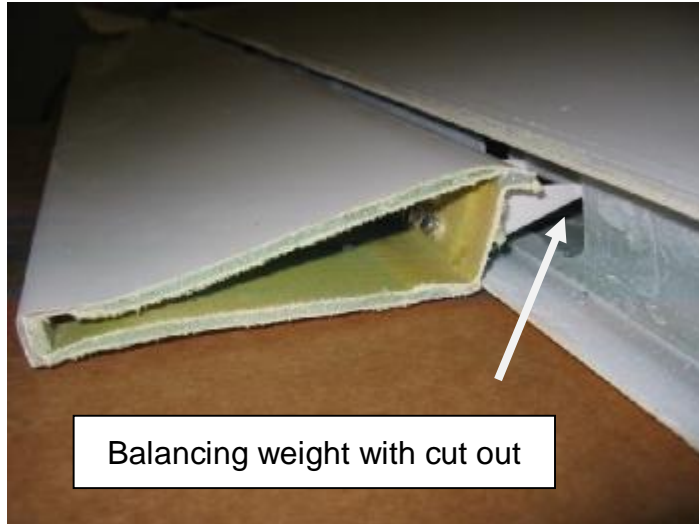
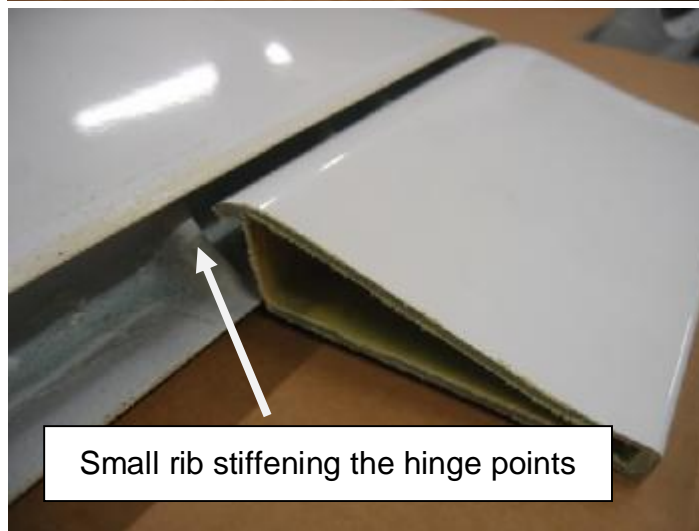
4.2 Pictures

Increasing play in the trim tab control system can lead to vibrations in the trim tab in flight at high speeds. This vibration can be clearly felt by the pilot when exceeding a certain speed and stops again when slowing down.

Pictures in the Appendix of this SB illustrate balancing weights with cut outs and the small ribs, which supports each hinge point.

Stiffening of the rear wall of the stabilizer by installation of ribs in the cut-outs for the balancing weights, and direct support of the individual hinge points with small ribs.
