Service NOTIFICATION

Coolant hose chafing

SN-LTUL-CT__-03;
SN-LTUL-CT2k-04

TECHNICAL ADVISE No. 4

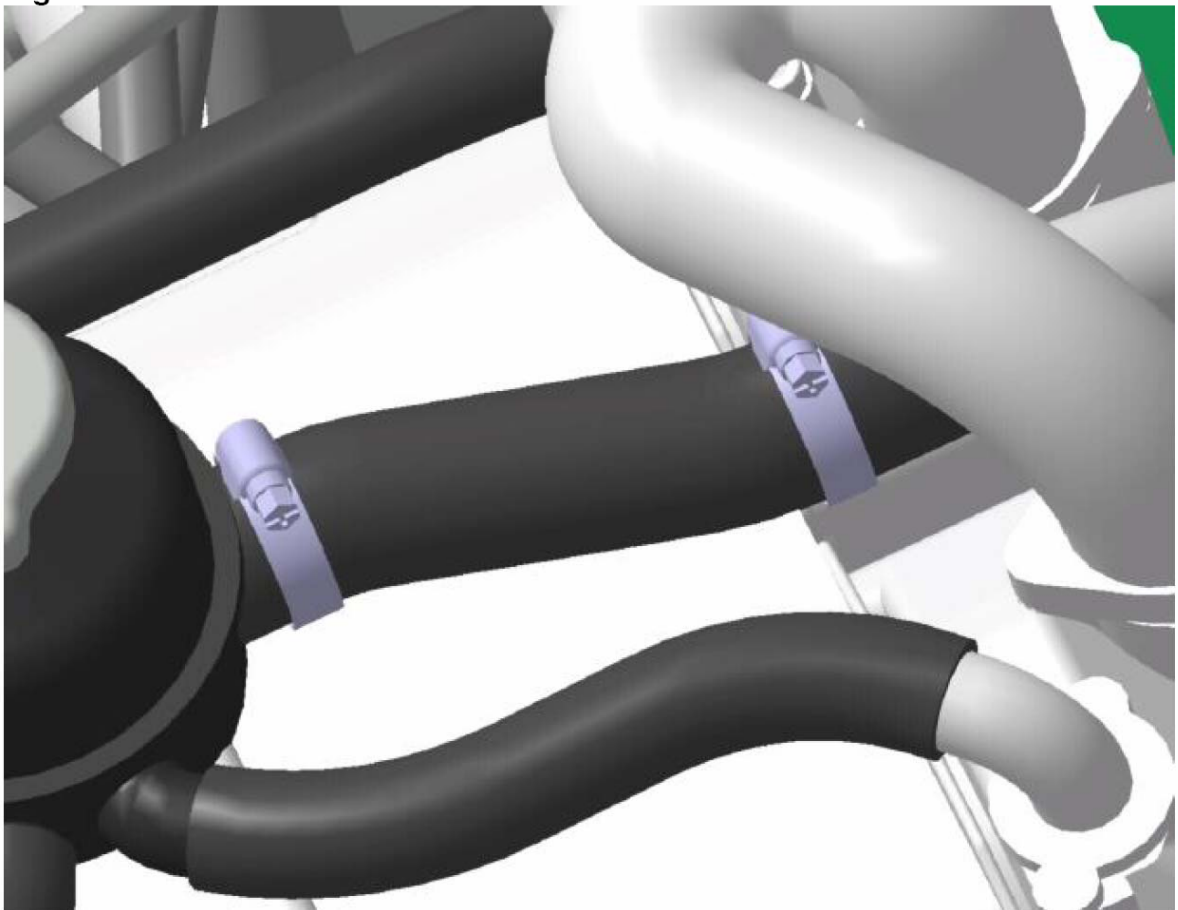
Fig. 1

According to information from UK there can be a problem that one of cooling system rubber hose gets worn against cast inlet air manifold of the engine.

Aluminium pipe routed from cooling liquid expansion tank on the top of the engine under left cylinders air inlet manifold (see fig.1) down to radiator was modified to more simple shape utilizing one-plane bends. With that the distance from expansion tank to upper edge of aluminium tube increased from about 2 up to about 7 cm and clamp was moved outside (see fig.2).

Please check if you can see in your plane rubber hose fixing clamp installed outside the air inlet manifold, please check wearing of the rubber hose against the manifold. If the rubber hose is worn out without having an aluminium tube under it and being clamped between manifold and expansion tank, replace rubber hose and the aluminium tube to a longer one.
