# Service NOTIFICATION

## Coolant hose chafing

**SN-SECS-CT\_\_-03;**

**SN-SECS-CT2k-04**

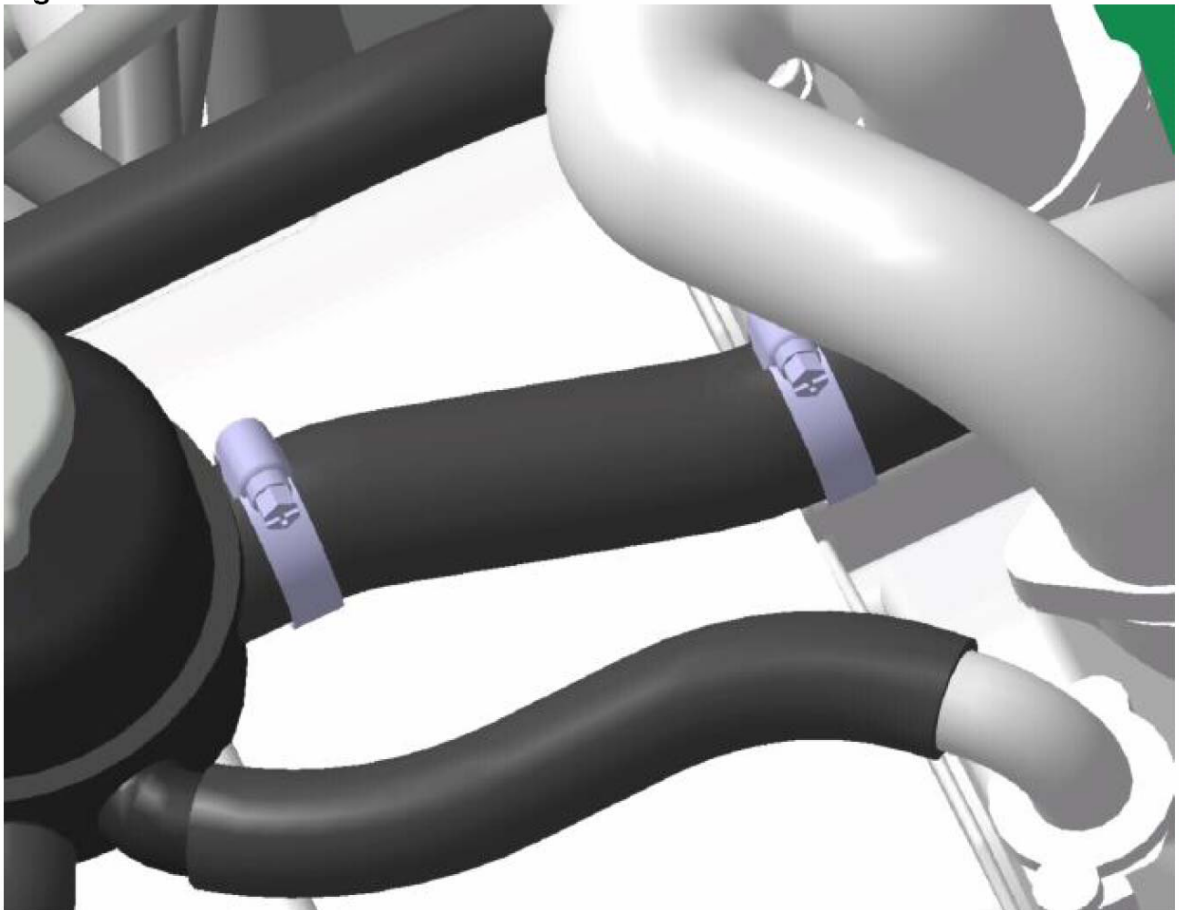
**Fig. 1**

According to information from UK there can be a problem that one of cooling system rubber hose gets worn against cast inlet air manifold of the engine.

Aluminium pipe routed from cooling liquid expansion tank on the top of the engine under left cylinders air inlet manifold (see fig.1) down to radiator was modified to more simple shape utilizing one-plane bends. With that the distance from expansion tank to upper edge of aluminium tube increased from about 2 up to about 7 cm and clamp was moved outside (see fig.2).

Please check if you can see in your plane rubber hose fixing clamp installed outside the air inlet manifold, please check wearing of the rubber hose against the manifold. If the rubber hose is worn out without having an aluminium tube under it and being clamped between manifold and expansion tank, replace rubber hose and the aluminium tube to a longer one.
