<b>Service Bulletin</b>	
	<b>Flight Design GmbH</b> Zum Tower 4 01917 Kamenz Germany Tel.: +49 (0)3578 37335 0 Fax: +49 (0)3578 37335 69 E-Mail: <a href="mailto:airworthiness@flightdesign.com">airworthiness@flightdesign.com</a>	<b>SB-ASTM-CTLS-13</b> <b>Revision 00</b>
	Date of Initial Publication: <b>04-Aug-2016</b> Publication Date of this Revision: <b>04-Aug-2016</b>

## Verification of Stabilator Mounting Pivot SB-ASTM-CTLS-13

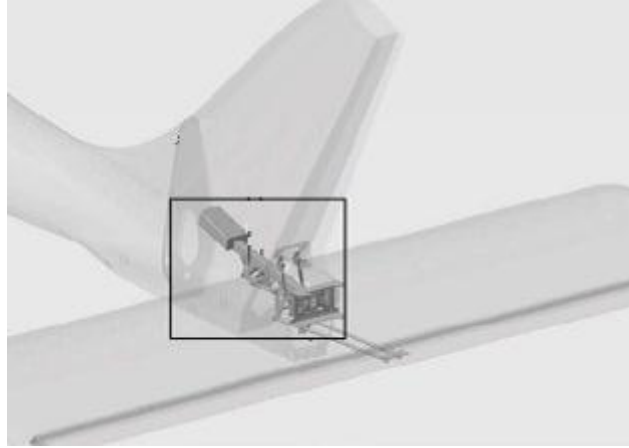
Stabilator mounting pivot, as part of aircraft stabilator control system, is located in the rear side of fuselage (Fig.1).

Fig. 1 – Sample view of the location of the stabilator mounting pivot on aircraft.

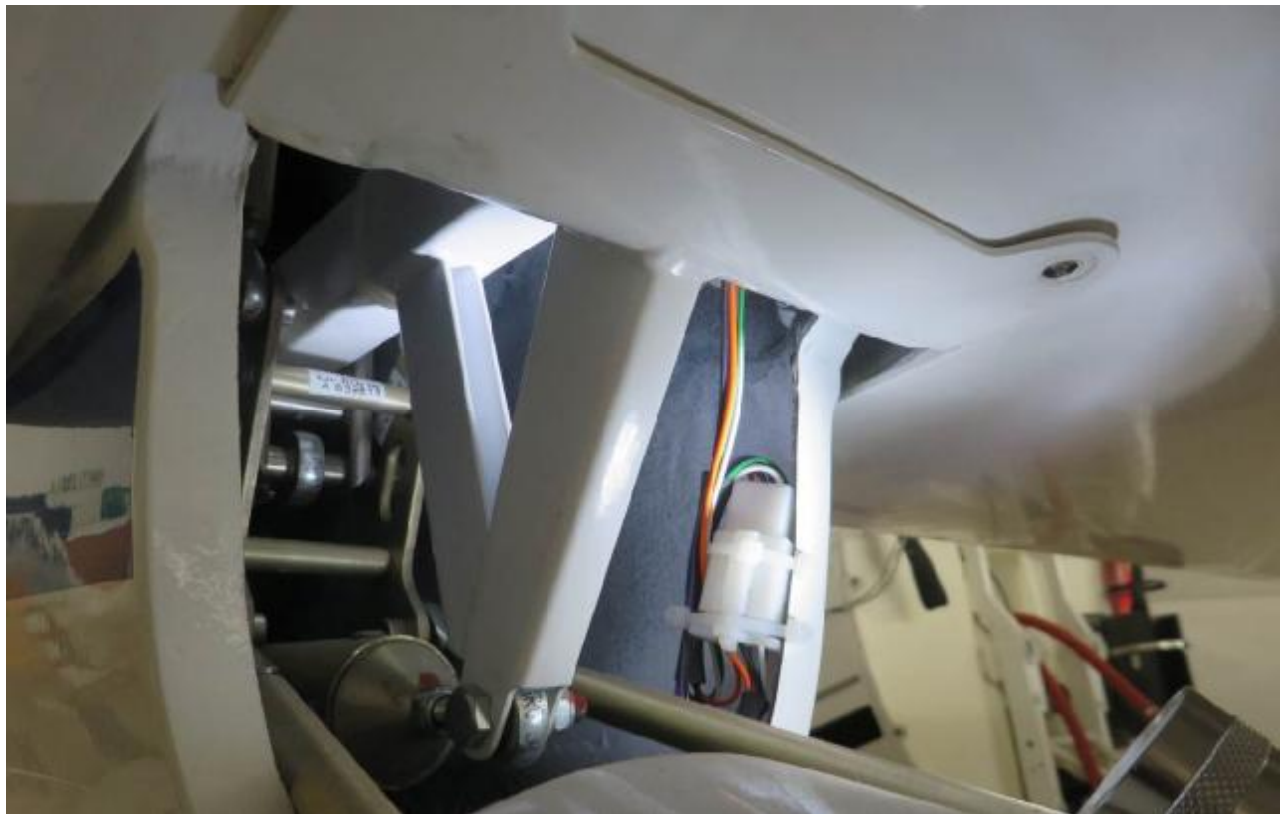
Fig. 2 – General view to area of stabilator mounting pivot to be inspected.

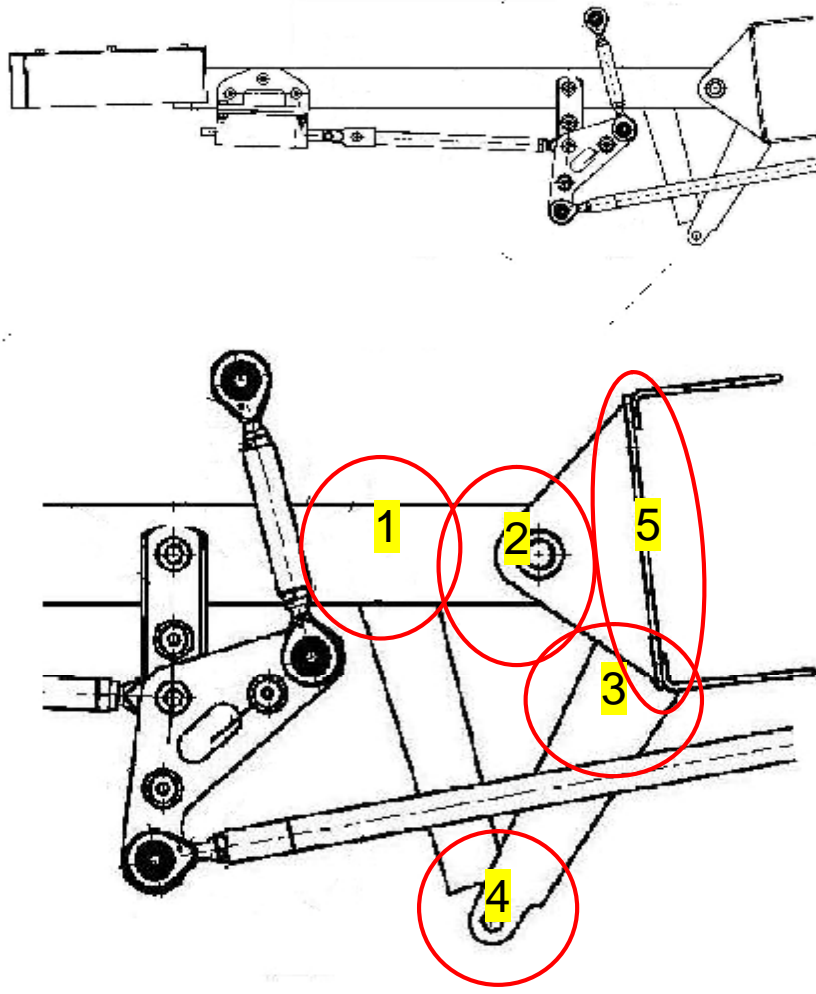
Fig. 3 – Areas of stabilator mounting pivot to be inspected (shown on the sample of stabilator mounting pivot with mechanical trim option).

Part is in normal condition when there is no visible crack on part surface and on welding seams in specified areas (Fig. 3).

Part is **not non-conformant** when observed visible cracks on part surface (in specified areas, see Fig. 3) or/and observed material cracks on welding seams of part.

- Check area of connection of pivot control lever to pivot arm (area 1, according Fig.3);
- Check area of connection of pivot arm and pivot axis support (area 2, according Fig.3);
- Check area of connection of pivot axis support and pivot control lever, rear side (area 3, according Fig.3);
- Check area of pivot control lever (area 4, according Fig.3);

- Check area of pivot axis support (area 5, according Fig.3), especially in corners of part (from left and right side of part).

In case of stabilator mounting pivot non-conformance, and when the aircraft is at a workshop adequately qualified for the re-installation of the part, remove the non-conformant part according to the instructions shown in aircraft maintenance manual [1], chapter 4.3.5.4.

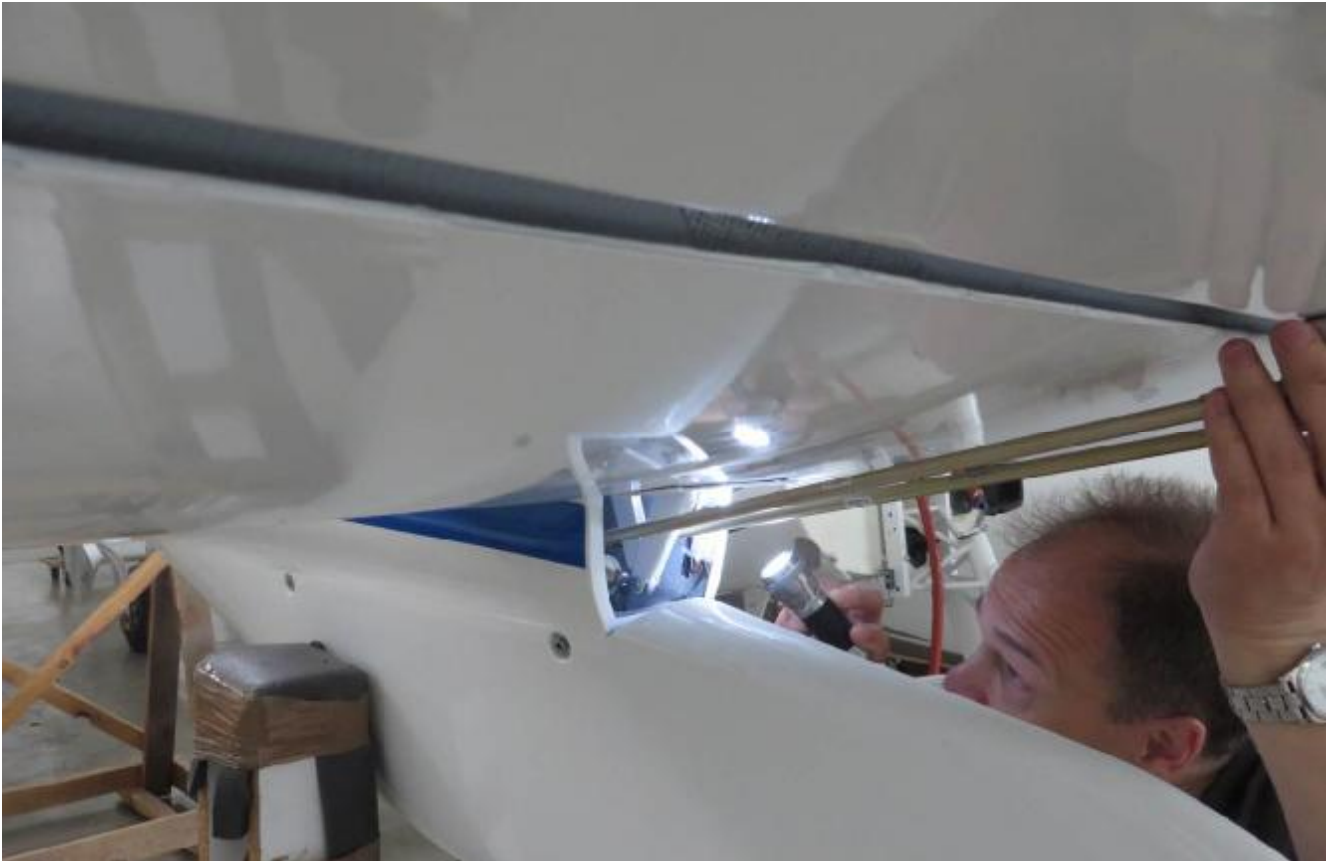
Fig. 4 – Inspection of stabilator mounting pivot.

Conduct following inspection steps (use flashlight and inspection mirror when required):
