SERVICE BULLETIN

Rudder Centering Fork - Control Stop Replacement

SB-LTUL-CTLS-05

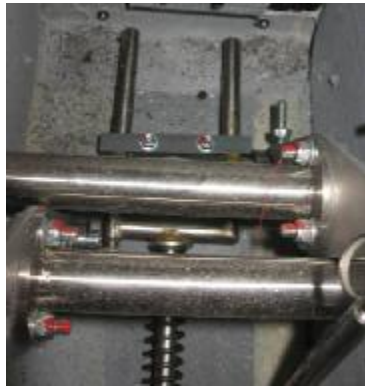
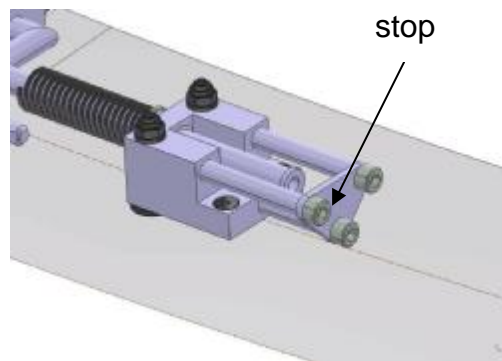
This is the rudder stop system that was installed to the CTLS affected by this SB ex factory. In this system the stop is provided to the rear end of the rudder centering fork, installed to the tunnel, below the instrument board. See following Fig. 1, 2 for illustration.

This system is the system affected by this SB.

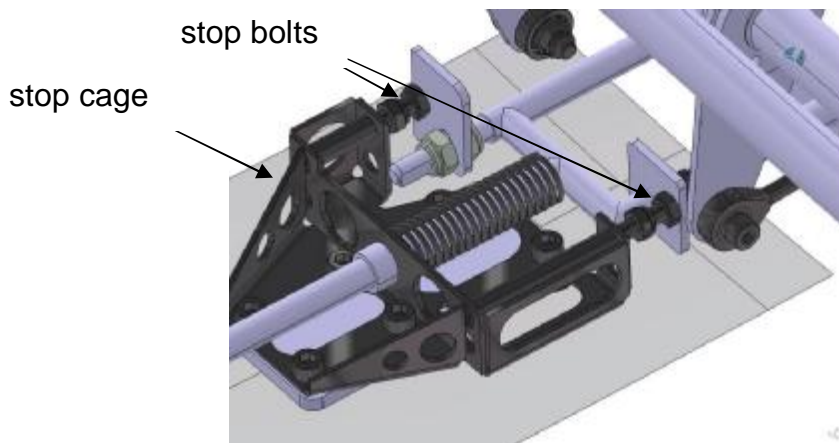
The new fork stop system provides a stop not to the rear end of the rudder centering fork, but to the thrust plates where the rudder centering fork contacts the bolt heads from the rudder pedal levers. The variant is clearly recognizable by the steel welded cage that provides the stops by means of adjustable bolts. See following Fig. 3 for illustration.

This stop device represents the valid type design and is used in serial production at the time of issuing of this SB. Only on aircrafts where the Rudder Stop Plates as by 3.1.3 cannot be used, this new fork stop system must be installed following this SB.

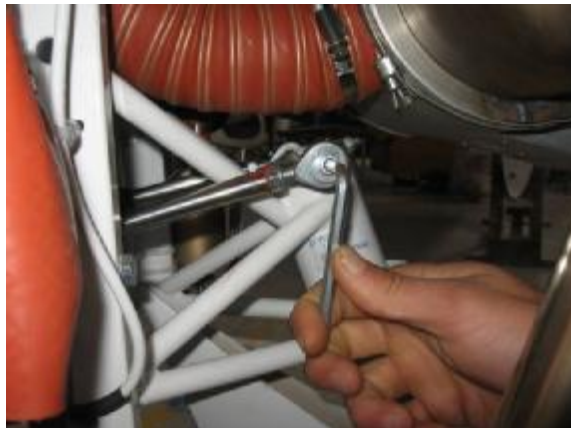
Detach the pushrods of the nose wheel steering – unscrew two (2), DIN 912 M6 bolts from the left and right sides (Fig. 7, 8).

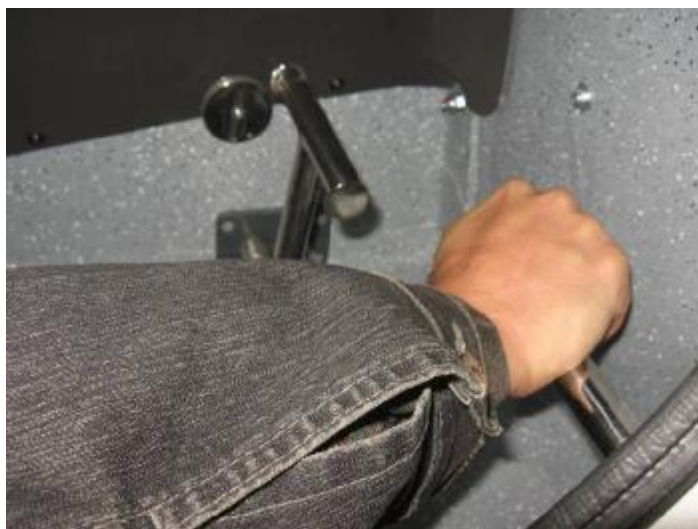
Fig. 9

Warning: Keep pedals in neutral position during removal of the rods (Fig. 9). The spring force of the rudder centering fork will push the pedals towards the seats as soon as one of the pushrods is released. It is best done with one person holding the pedals and carefully releasing them after detachment of the pushrods.

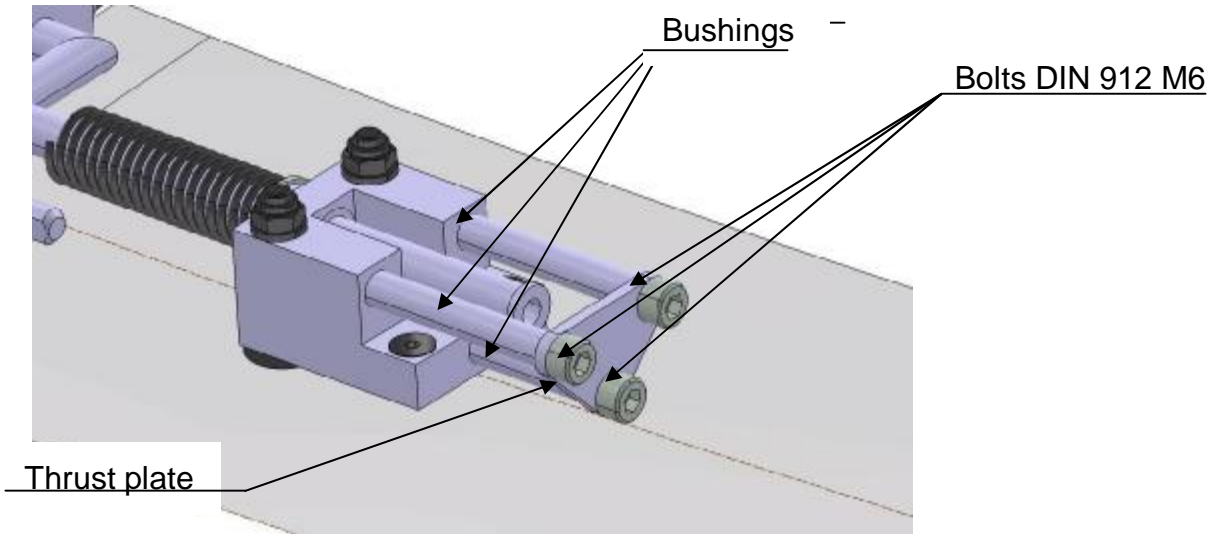
Fig. 10

The old fork stop system, that guides the rear end of the rudder centering fork, must be uninstalled when the rudder stop plates are installed. To do this, remove the three bushings, bolts and thrust plate shown in Fig 10 from the fork mount block. Unscrew three (3) DIN 912 M6 bolts (Fig. 10). Discard these parts.

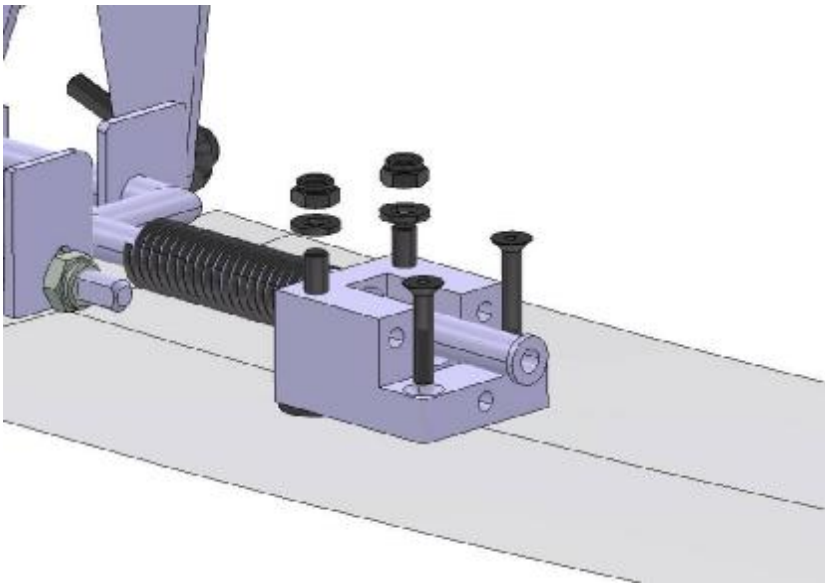
Fig. 11

Remove the rear aluminum fork mount block from the lower fuselage skin by unscrewing the 4 bolts as shown in Fig. 11.

Warning: The spring installed to the rudder centering fork provides a pretension to the system and will push the aluminium block to the rear, once all bolts are removed.

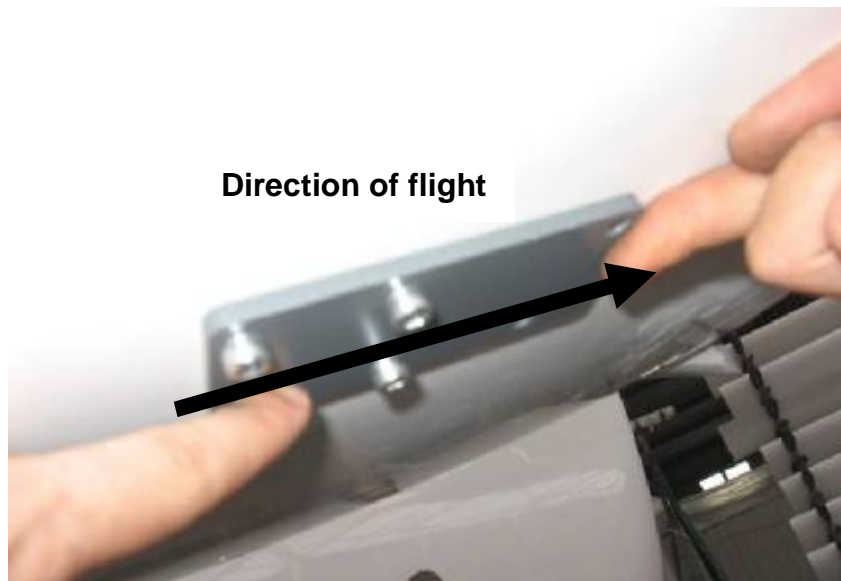
Fig. 12

Temporarily install PVC plate KF27200223 from the outside to the bottom fuselage using four (4) bolts (Fig. 12).

Warning: Installation must be exactly in the same position as the installation will be later on in the aircraft, so not turned upside down. When looking in direction of flight, the most forward hole on the left side must be rear of the most forward hole on the right side. Pay special attention, when drilling the holes you look from below. In case of doubt use the new fork stop cage to cross check. See Fig 6.

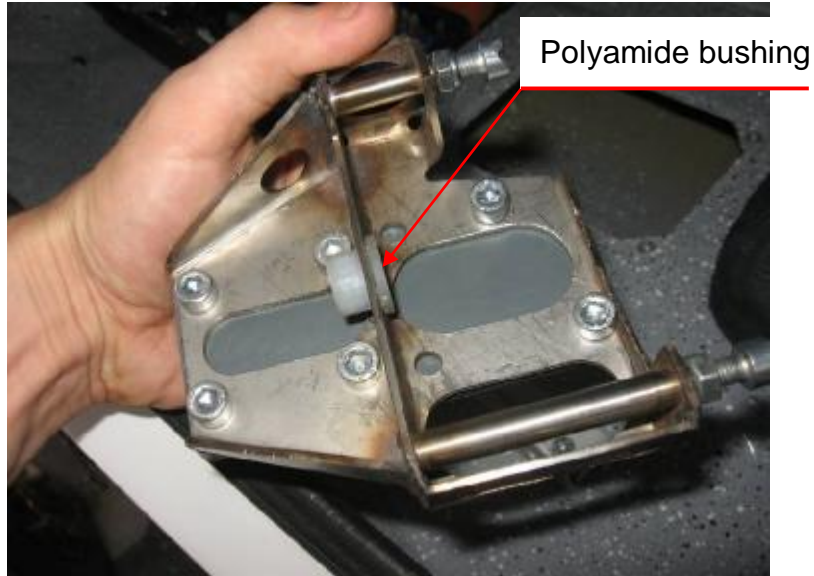
Fig. 13

Remove polyamide bushing from the aluminum support that was uninstalled in step 3.3.3. Install this polyamide bushing to the guide hole of the new rudder stop device (Fig. 13).

Take the new fork stop system cage and place the PVC plate on the lower side and insert the 6 attachment bolts (Fig 13).

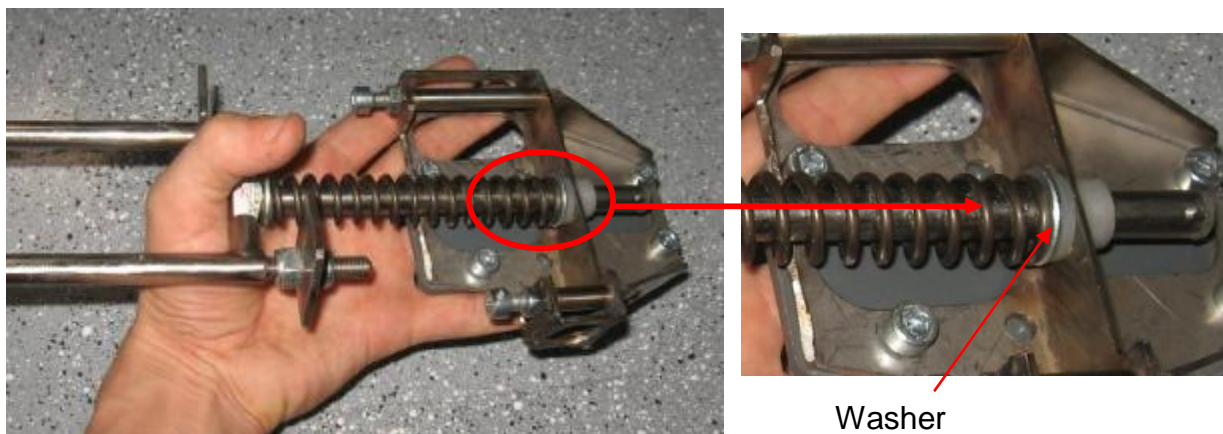
Fig. 14

Insert rear guide of the rudder centering fork to the new fork stop system cage as shown in Fig 14.

Warning: Install one (1) washer between the spring and polyamide bush (Fig. 14)

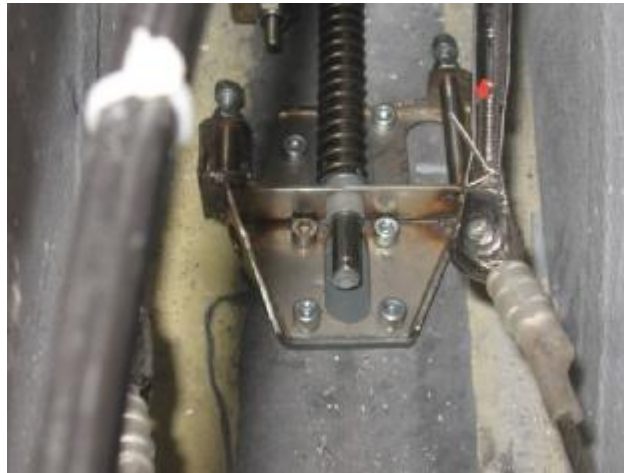
Fig. 15

Now the set of rudder centering fork and new fork stop system cage can be positioned into the fuselage. The fork is inserted to the front fork guide and the new fork stop system cage is attached to the six (6) attachment points on the fuselage floor (Fig. 15).

Install washers DIN 9021 6.3 mm from the outside of fuselage. Install new self-locking nuts M6 on each bolt. Apply tightening torque: 9 Nm.

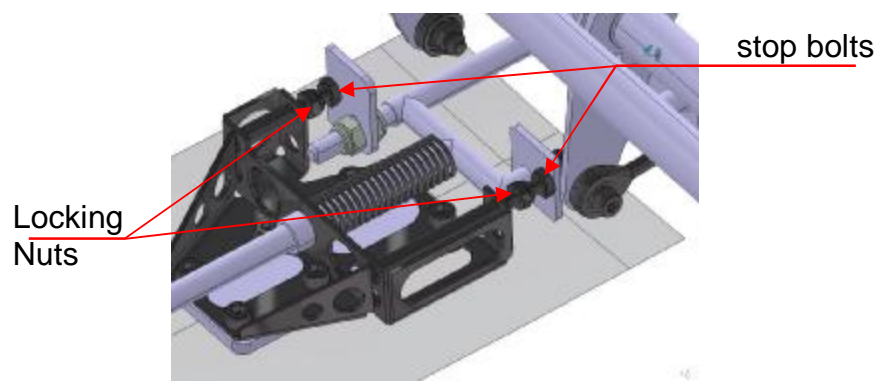
Fig. 16

Adjustment of the rudder stops is achieved by changing the length of the stop bolts, inserted to the new fork stop system cage (Fig. 16). When deflected, the fork plates are pushed against these stop bolts. Changing both of the bolts allows increasing or decreasing the maximum rudder deflection.

Warning: The stops on both sides of the new system must be installed so that the stop at the side where the pedal is deflected touches the centering fork first or at the same time as the other side does. The opposite stop from the deflected pedal cannot touch first.

After finishing of the adjustment tighten the locking nuts (Fig 16) on the stop bolts.

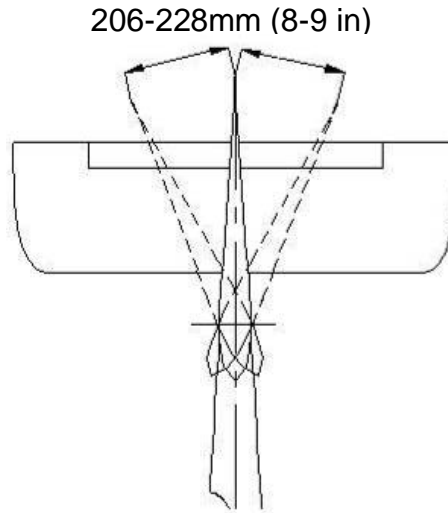
Fig. 17

Maximum rudder deflection is measured at the lower trailing edge of the rudder as shown in Fig 17.

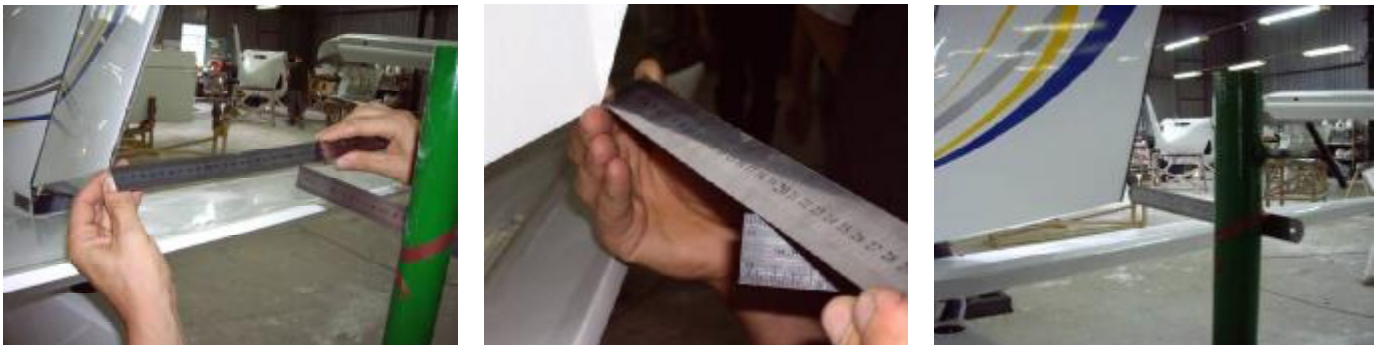
Fig. 18

To measure this deflection, position a pointer/reference marking the rear lower edge of the rudder in the neutral position. Then deflect the rudder by pushing the pedals up to the stop and measure distance between pointer and deflected rear edge of the rudder (Fig. 18).
